# Developing A Structure for Surveying Portuguese Dwellings: Integrating Inspection and Heritage Conservation Theory in Practice (Part II)

Matthew Nouch<sup>1</sup> and Paula Lamego<sup>2</sup>

**Abstract:** *A model suitable for the evaluation of the state of conservation of older buildings, applicable to a Portuguese setting, was presented in a previous edition of this conference. This model emerged from a review of a substantial body of relevant Portuguese and international work from the past two decades, to ensure a transparent, integrated approach to decision-making when intervening in the historic built environment. The model divides structures into their individual components – walls, flooring, ceilings, roofs and terraces and drainage – whilst understanding their interconnected nature. This paper, the second part of the series, presents and explores the model in further detail, critically engaging with how it works when implemented in the real world, specifically with regard to the “walls” component. The paper examines the model’s data collection, analysis and prognosis processes and, drawing from extensive practical data, discussing the model’s effectiveness in identifyi

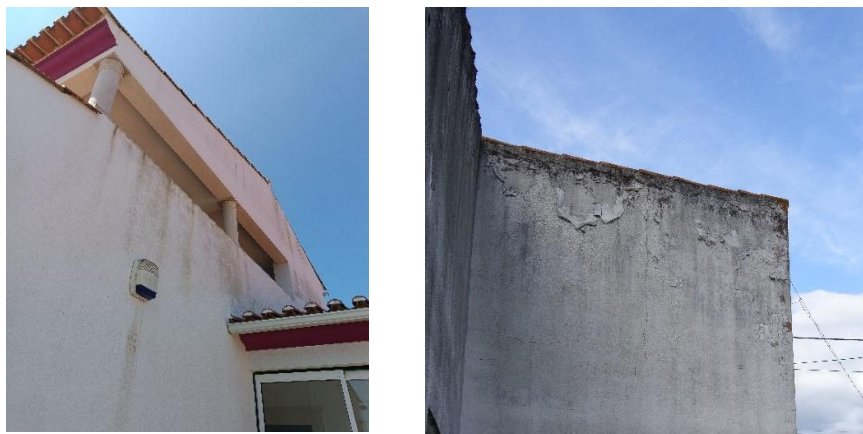
Fig. 3 (left) and Fig. 4 (right) showing the impact of moisture damage and associated biological colonisation on poorly resolved and protected verges and parapets.

Unfortunately, and as per the diagnoses in Table IV, problems of poor design and implementation of regulations persist in Portuguese construction with regard to the distinct yet interrelated phenomena of efflorescence, the presence of microorganisms, blistering, and other marks. These are present in buildings of all ages and construction types. Manifestations are indicative of a lack of resistance to moisture (damage) of the building envelope through the lack of damp proof courses, not to be expected in older buildings but advisable for newer dwellings, resulting in rising damp via capillary action. Combined with an inconsistent approach to guttering allowing rainwater to splash back onto walls and, finally, almost universally a deficiency in internal ventilation, avoidable or mitigatable degradation to walls occurs. More recently, these phenomena have been exacerbated due to an architectural trend towards shallow verges (often on gable end walls) and uncapped horizontal parapets (Figures 3 and 4).
