Analysis and Technology Rating of the Rural Architecture

Antonio Passaro

Department of Architecture, Federico II University of Naples (IT) - DiARC

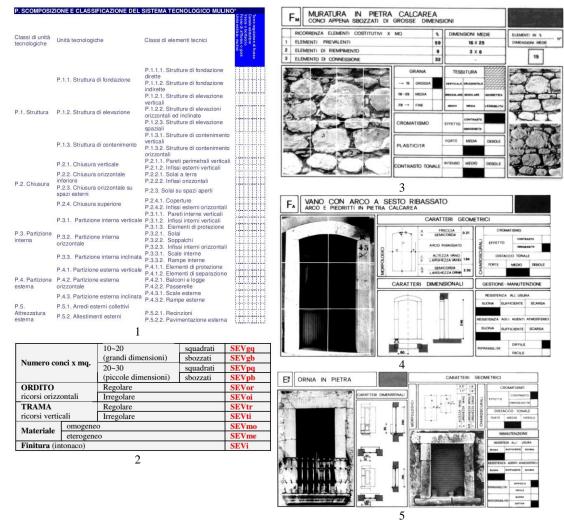
Fig 1: Building structure decomposition sheet, 2 - 3: analysis of masonry and the classification table with the encoding for masonry typology, 4 - 5: Sheet type for the openings of ground floor and upper floors

the reading of finishing elements of the walls⁴, the openings, the crowning frames, doors and windows, etc. (Figure 4,5) enabling an analysis of how the components are presented and combine with each other by establishing concordances typological through effects: colour (homogeneous / mixed); light / dark (strong / weak); geometric (agree / disagree); textural (homogeneous / inhomogeneous). The schematic, settled in the interpretation of the structure of the relationship between the components and the analysis of the intensity of the resulting relationship, allows us a catalogue of perceived patterns most common in the areas under consideration. The detected and identified components can be described through the nature or origin and their specific properties, depending on: size - significant / insignificant (in relation to the observed system); geometry - linear / polygon; form - simple / complex; disposition (with horizontal development force lines, vertical, oblique, etc.); contours (soft / net, closed / open, continuous / discontinuous).

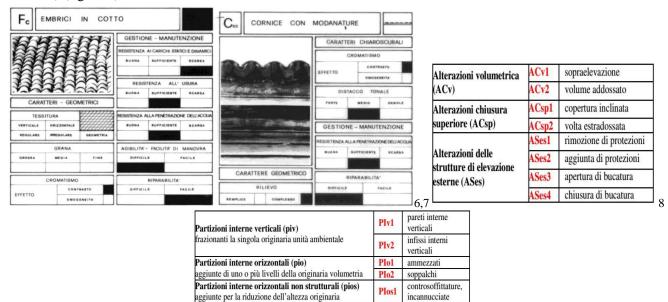
Fig 6 - 7: Classification of roof coverings and crowning cornices, 8 - 9: Alterations in environmental units (typologicalfunctional - AUA) and the volumetric configuration (typological- formal - AC)

surface coated with wrought lapillus, often shaped to channel the rainwater in cisterns. The pitched roofs are generally classified into the usual morphological families (in a flap, double-pitched, hipped, multi-pitched) but using simplified static solution (the trusses are almost entirely absent). The covering structure of the examined buildings is mainly achieved by the main structure (warping carrier in the transverse dimensions of beams proportional to the distance of the supports, with a section rather irregular, approximately rectangular or circular, of a size of about 25 or 30 cm.) which supports a transverse secondary structure of slats (small size 7/8 cm thick, placed at a distance of 40 cm.) on which are resting the orthogonally clay roof tiles (irmici). The roofing is closed and completed in the upper with roof bent tiles (cavallotti). The wood used is the chestnut, more rarely oak. In roofs in a flap, the load-bearing structure consists of beams resting on the perimeter walls of the ridge and eaves. In buildings with two flaps roof, the frame is placed on a median wall at right angles, or more rarely on a central longitudinal ridge beam embedded in the tympanum of the transverse walls. The slope is around 30-35%, upper limit beyond which the weight of the roof, under the wind loads and dynamic effects, results in slippage of the tiles. When installing the mantle, some stones were placed along the first row of tiles at the level of the eaves, which were used to prevent the lifting of roof tiles under the action of wind (fig6). Typically the eaves node of rural buildings is pretty simple, solved by protruding very little the last row of tiles from the vertical, without the presence of a gutter. A different solution, with a greater degree of finishing (however having the structural components in view and rarely plastered), is represented instead by the cornice which, depending on the rows of which it is composed, can be distinguished in simple, when it results from the horizontal overlap of two or more tiles of files, or composite, when the bent tiles of files interpose horizontal rows of brick or stone slabs (the concavity of the bent tiles places below the line of the eaves is either facing up or down) (figure 7).
